CASE NO. 6:20-bk-10583-SC

**Complaint To Determine
Dischargeability Of Debt Pursuant To
11 USC § 523(a)(2)(A))**

PROJECT: MURRAY'S RESIDENCE FRAMING REPAIRS
ADDRESS: 28728 PALISADES DR., LAKE ARROWHEAD, CA 92352
OWNER: VERNON MURRAY
ADDRESS: 215 N. MARENGO, PASADENA, CA 91101
PREPARED BY: ALEC SEAMAN CONSTRUCTION
ADDRESS: P.O. BOX 3070 BIG BEAR LAKE, CA 92315

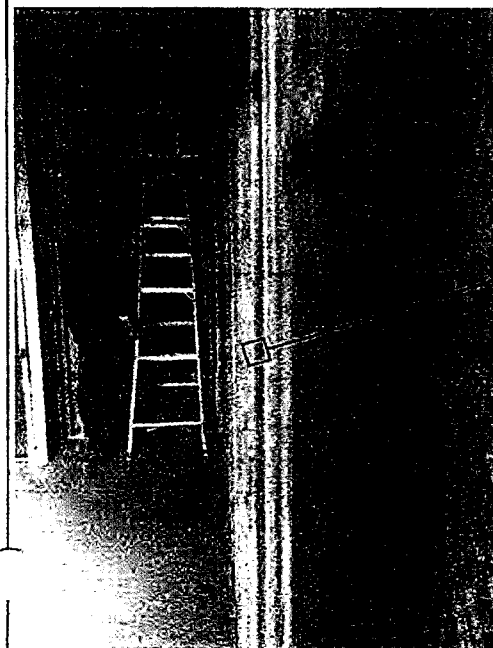
- See "NOTE B" above

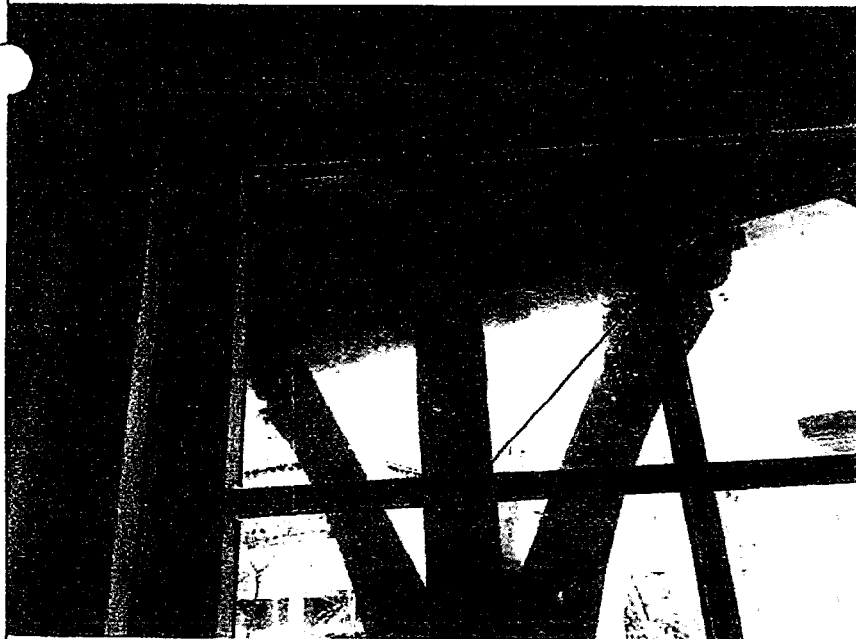
Structural deck posts are missing machine bolts at base where CB88 anchors posts.

Mechanical fasteners at post to girder connection missing. Install ornamental "T" straps.

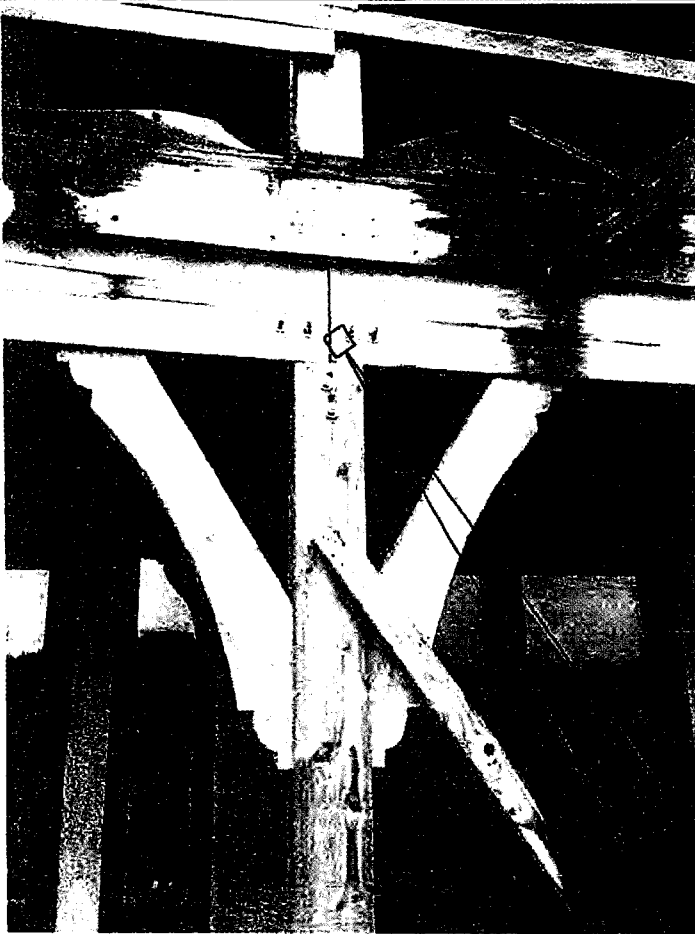
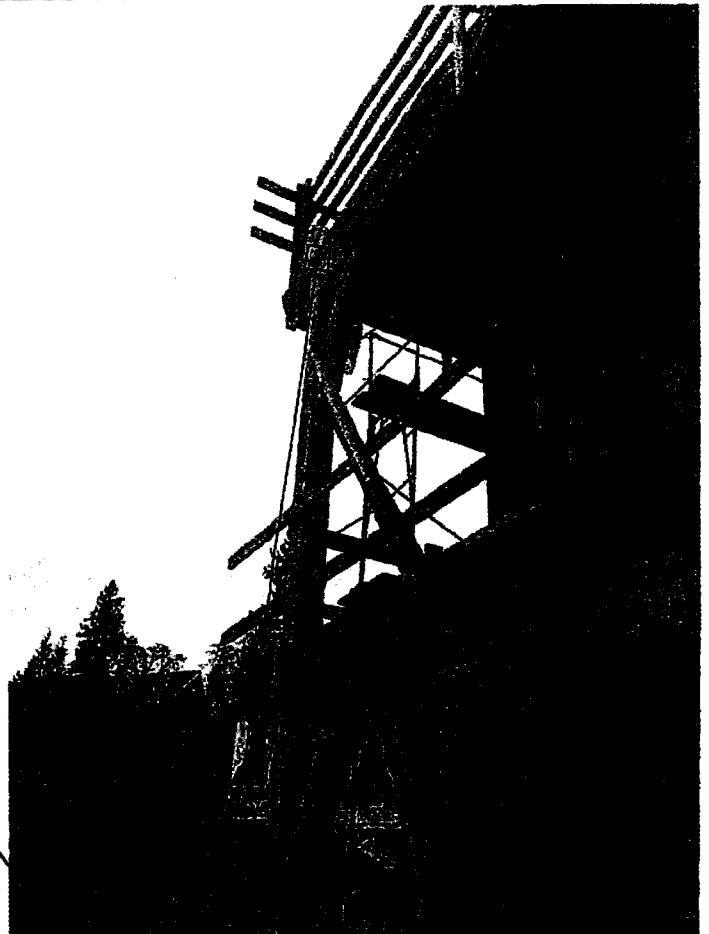
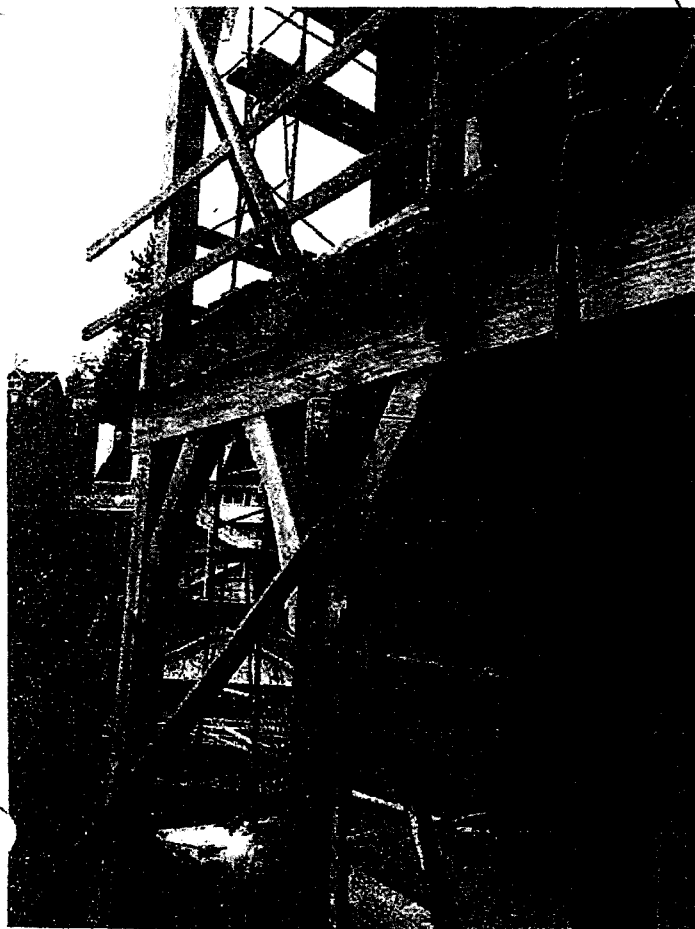
NOTE A

Lower level and middle level decks are supposed to finish out with the same length measurement according to plan.

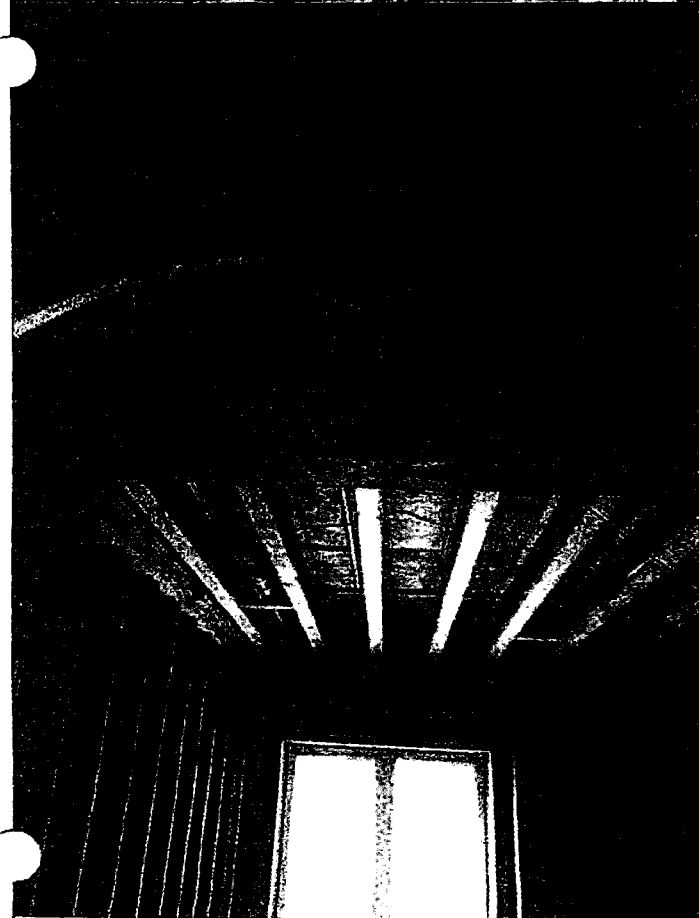
NOTE C

- MST strap missing nails

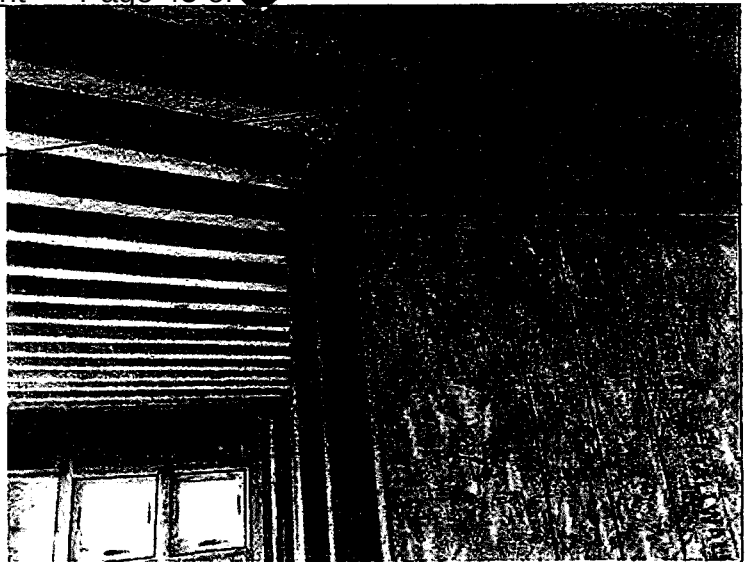
NOTE A

Miscellaneous drywall
backing missing, check
entire middle floor
ceiling for backing

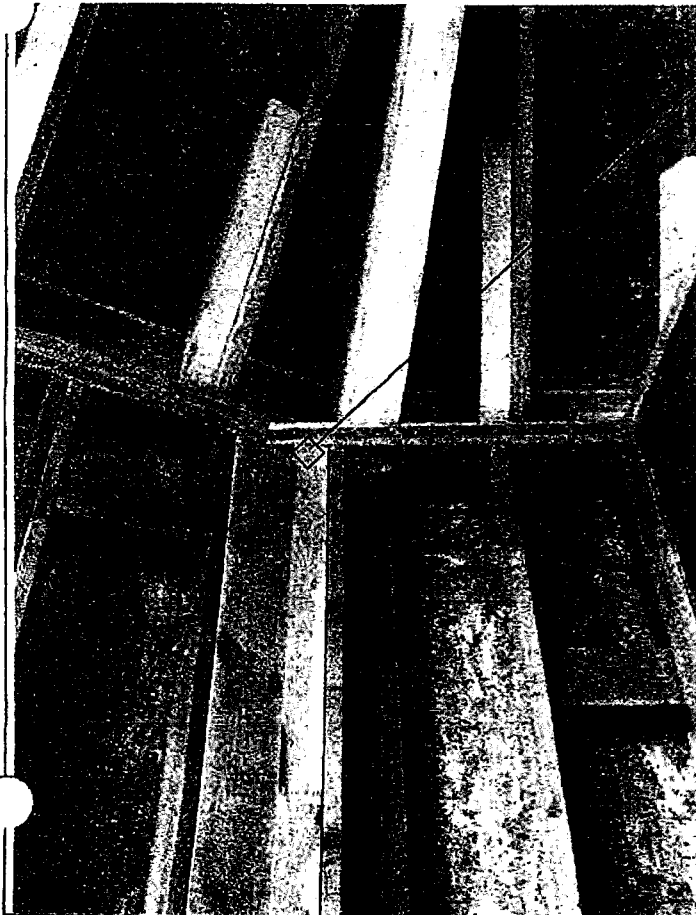
NOTE B

Because of the added plumbing wall, corner will not meet up with the valley as it ought to.

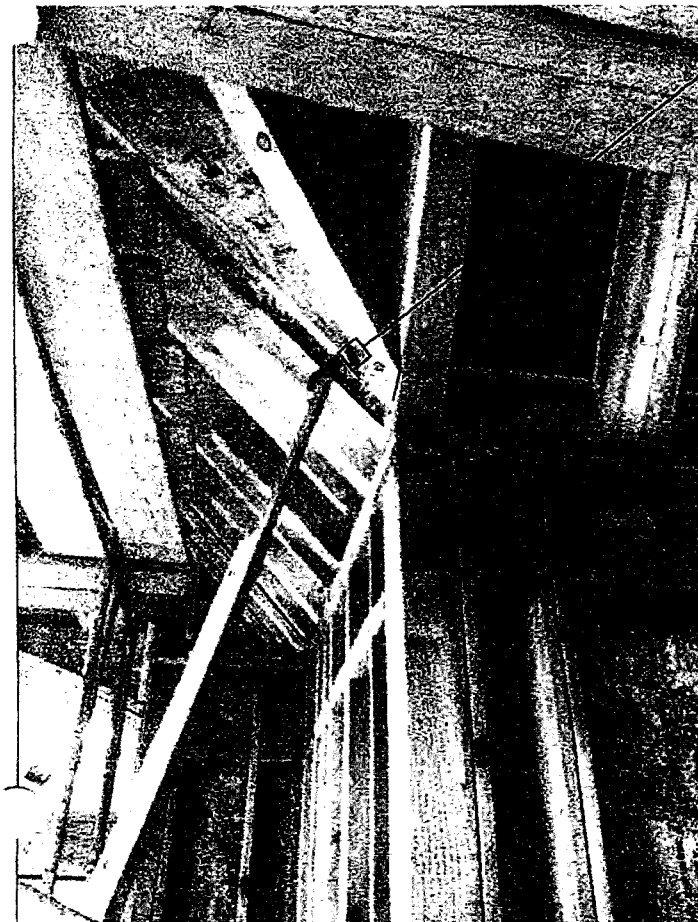
NOTE B

• Where rafter cuts extend past the valley rafter, valley rafter needs to be furred down for finished ceiling treatments.

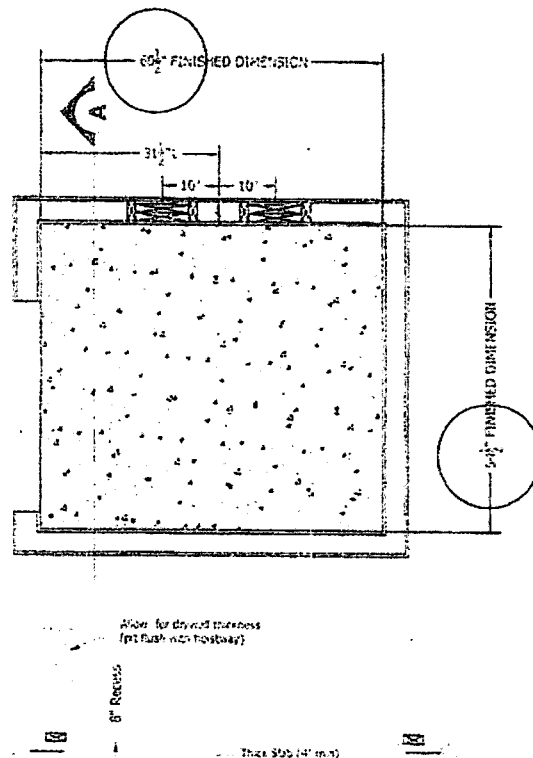
PIT CONSTRUCTION DETAIL

The next level up (middle floor) the existing shaft dimensions shrink down to 61 5/8" x 56", which will only allow for one layer of 5/8" drywall, which does meet the elevator manufacturer's/ installer's specifications. The main level and the top level follow this dimension. See Pg. 27 for elevator spec. with double layered drywall.

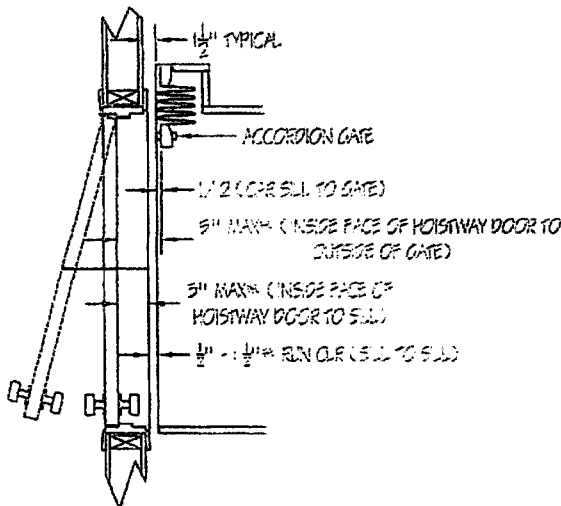
Final Elevator Shaft Dimension Requirements

Manufacturer's requirements for elevator shaft with two layers of 5/8" drywall shown here on this drawing 63" x 57" rough framing

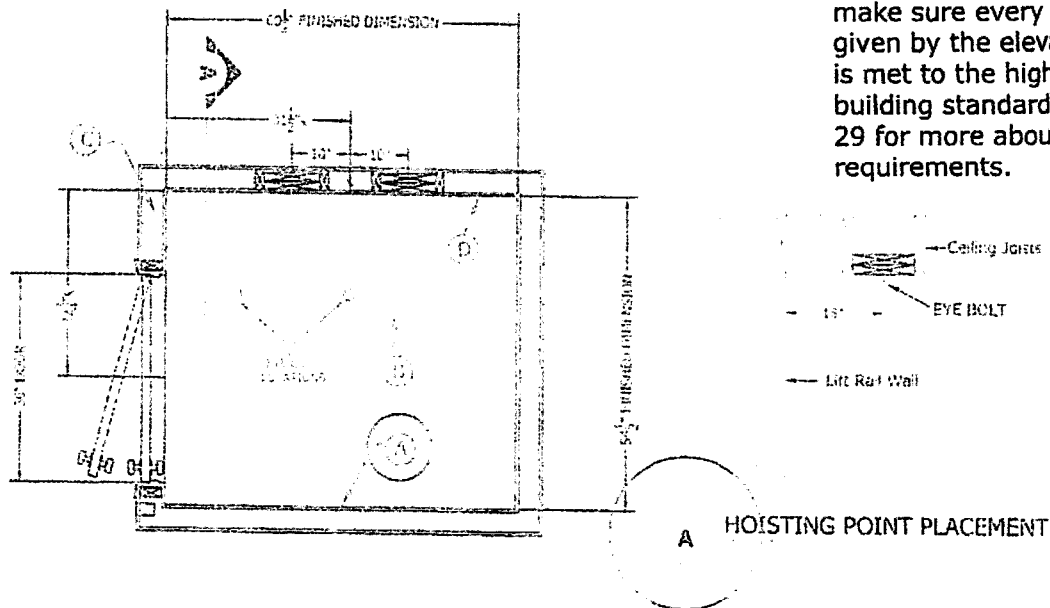
HOISTWAY FRAMING PLAN VIEW

See notes on Pg. 26 regarding Existing Elevator Shaft conditions.

Elevator shaft requires further inspection and corrections to make sure every specification given by the elevator company is met to the highest level of building standards. See pg. 29 for more about framing requirements.

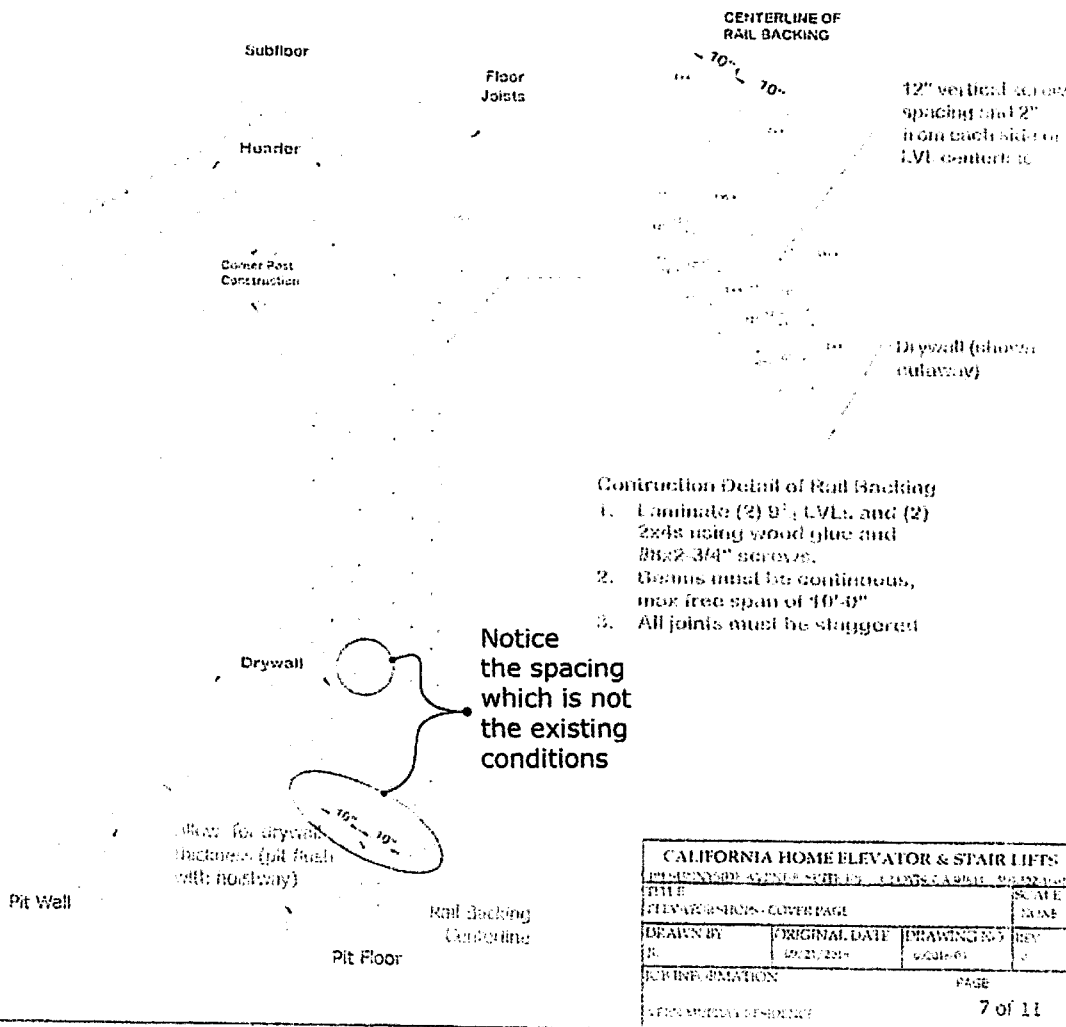
TYPICAL HOISTWAY CONSTRUCTION

Existing elevator shaft conditions as shown in pictures do not completely conform to the typical hoist way construction as shown in the manufacturer's/installer's details as shown on this page. Rail backing is also not installed in the correct places.

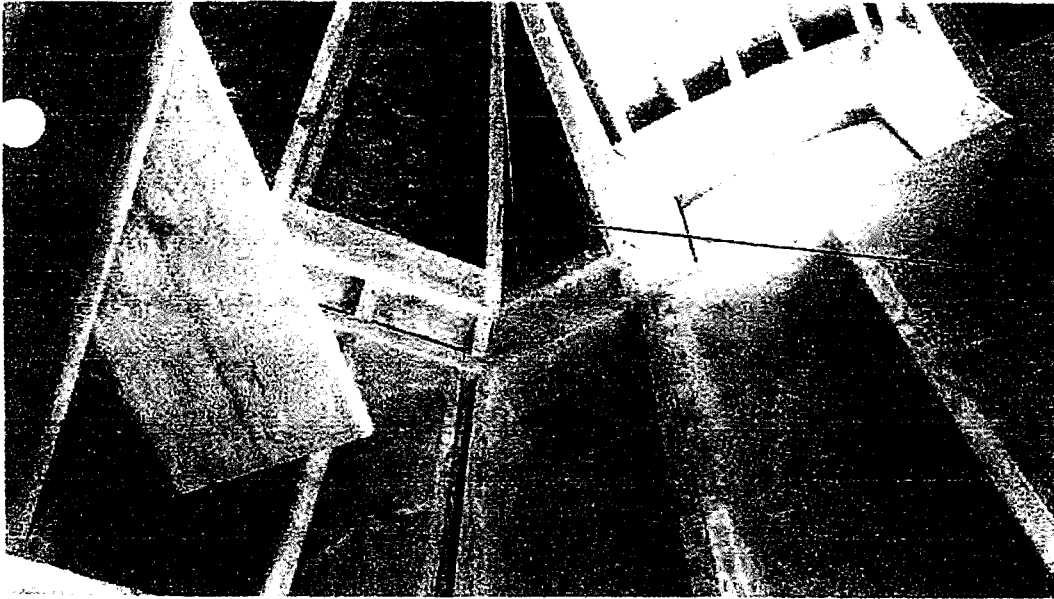
NOTE B

• Strings strung from corner to corner where they are supposed the corners are supposed to meet up/plane in.

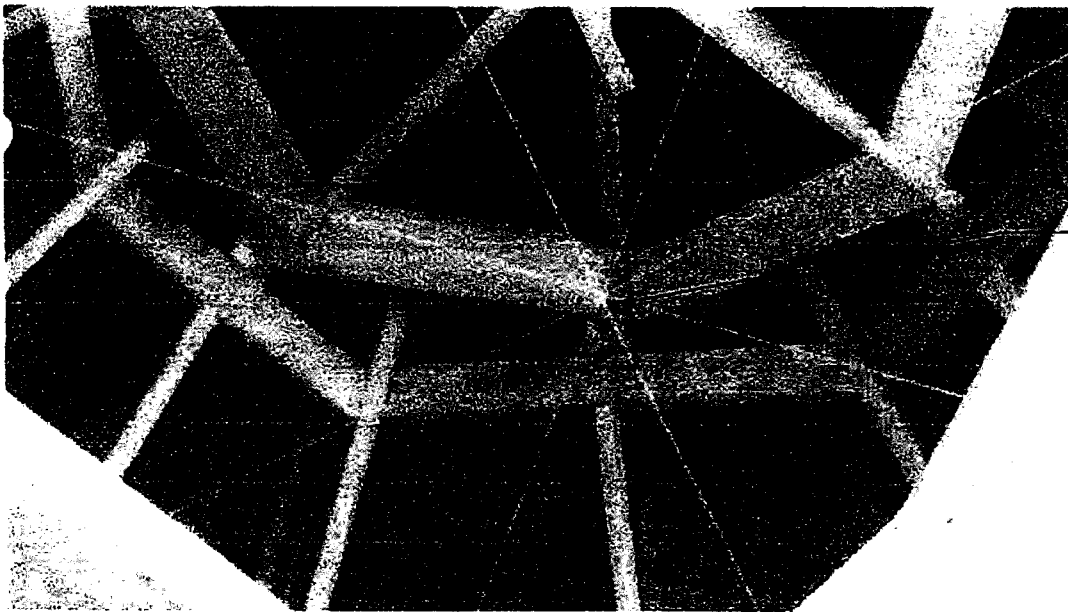
NOTE B

- Same as Note A

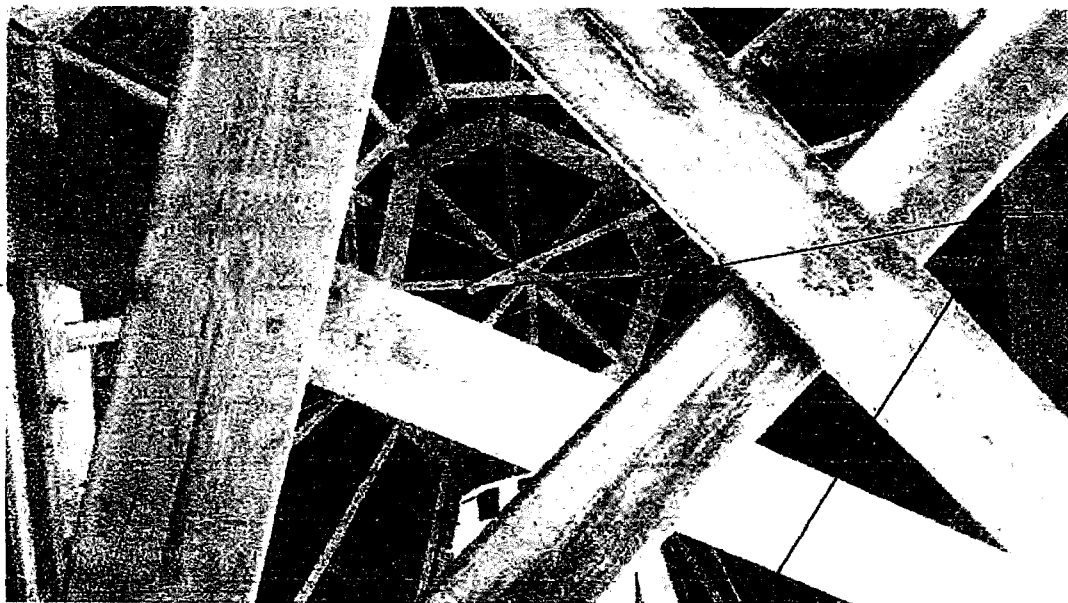
NOTE A

• Our string lines show the proper center point of turret.

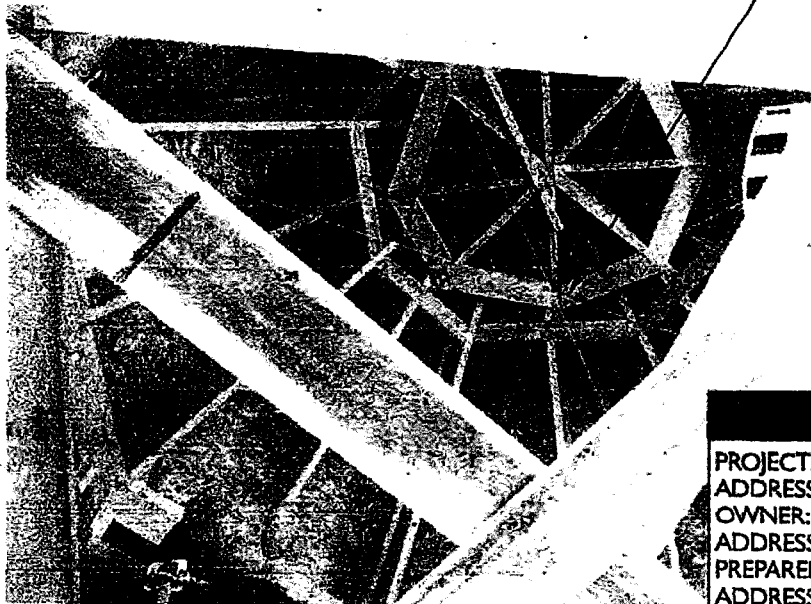
NOTE B

• Our string lines compared to the existing turret framing show how much correction is needed.

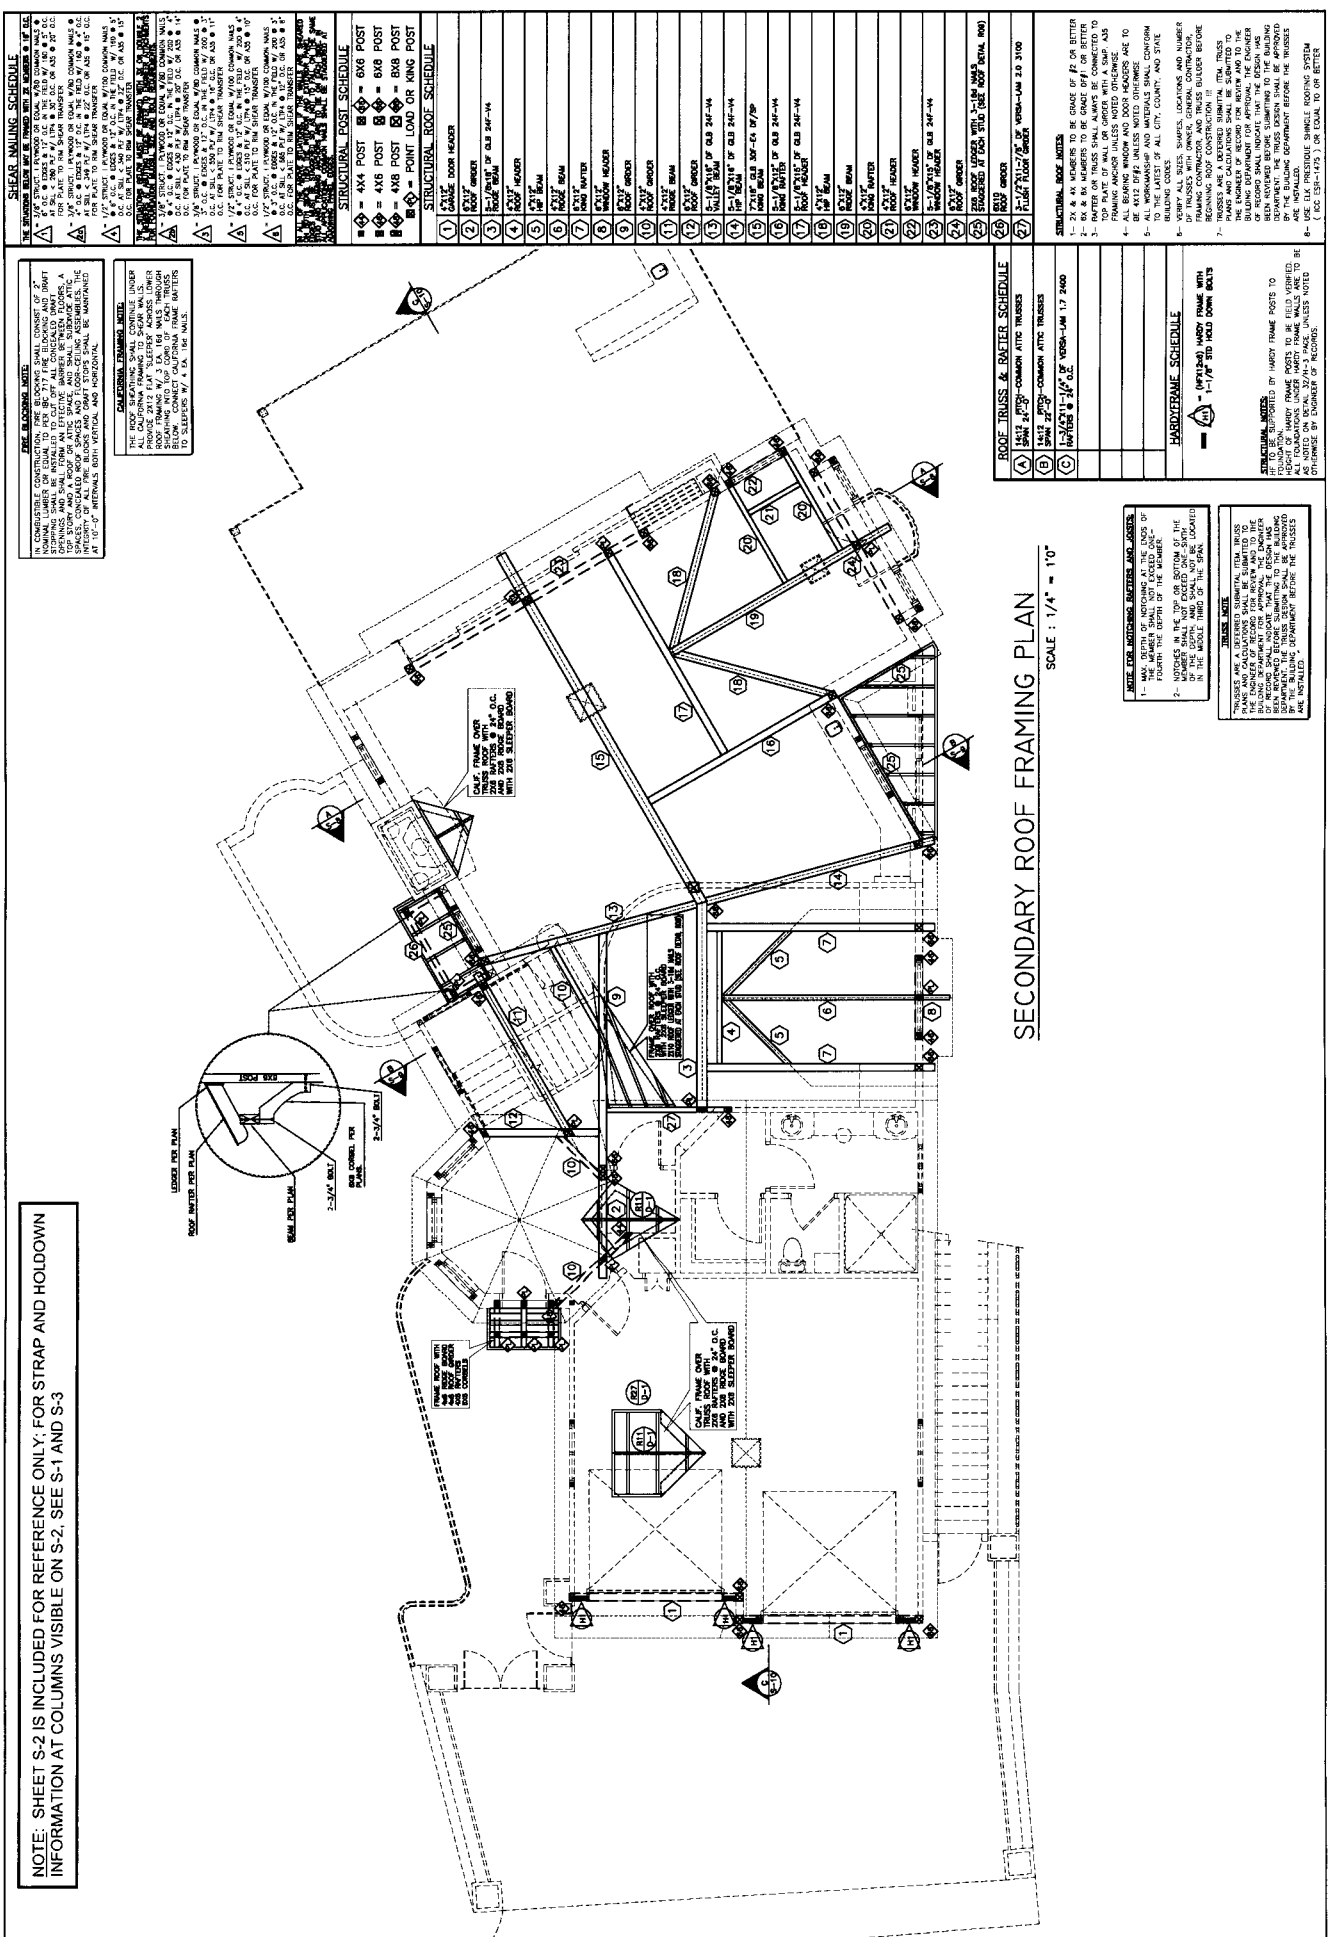
- A shear wall is considered discontinuous where a shear wall exists at one floor but is not supported by another shear wall directly on the floor below. This condition taken alone does not necessarily constitute an unsafe condition. The condition is considered safe only when the "missing" shear wall is replaced by other elements that can transfer the shear wall loads ultimately to the foundation. This includes the diaphragm to distribute the shear wall shear force and transfer girders or posts to transfer the shear wall overturning forces. We identified six instances of discontinuous shear walls where we could not identify sufficient transfer girders and posts (Attachment A). Among these, five instances occurred with no indication on the permitted drawings specifying a transfer girder or support post. We identified one location where the drawings specify a transfer girder, but we did not observe the transfer girder in the as-built framing (in the field). Our site observations were not comprehensive, and there may potentially be other transfer girders shown on plan but missing in the field.

- Detail WD31/D-2 shows Simpson clips providing attachment between shear wall plywood sheathing and the floor joist above for walls parallel to the floor joists. We observed several interior shear walls parallel to floor joists that were installed without ensuring that additional floor joists were in place directly above the wall to facilitate attachment using clips. Without adequate connection to the floor diaphragms, these shear walls cannot serve their purpose in resisting seismic loads.
- Degree of importance: Critical.

- We recommend the SEOR review the discontinuous shear walls identified in Attachment A and provide a calculation that demonstrates the adequacy of the current shear wall configuration or a recommendation to mitigate the situation if it is found to be inadequate. If mitigation is necessary, we can provide recommendations for cost-effective solutions.

- We recommend the SEOR resolve the design and construction conditions related to the shear walls with inadequate connection to the floor above. Alternatively, we recommend the diaphragm connection for each interior shear wall parallel to the floor joists be inspected and, where missing, additional floor joists added above walls as described in the Structural Floor Notes Item 6 on Sheets S-3 through S-6. Joists shall be connected to shear walls per Detail WD31/D-2. Where it is impractical to add floor joists, additional framing can be designed to connect the top of the shear wall to the diaphragm.
